San Diego International Airport

San Diego County Regional Airport Authority
San Diego, CA

February 27, 2013

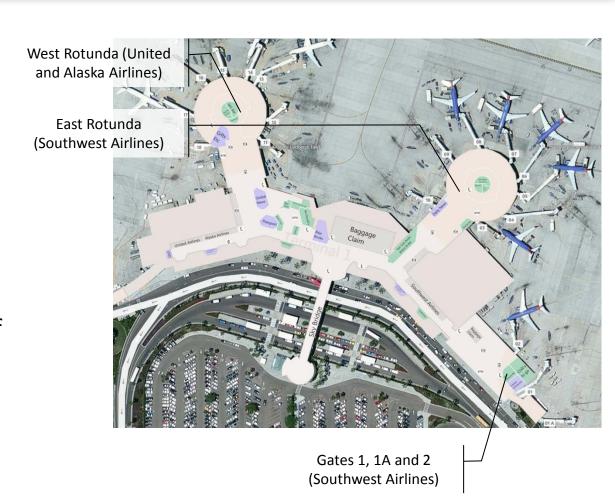
284,000 square feet building on one and a half levels

■ 19 gates:

- 16 around two pier structures (gates 3 through 18)
- 3 at the far east end of the terminal

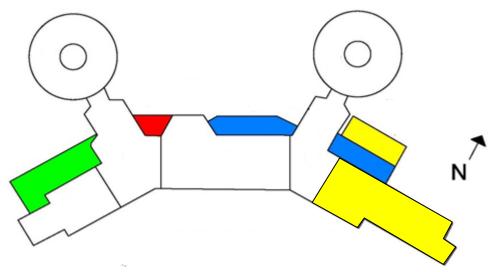
Original Terminal 1 structures and modifications

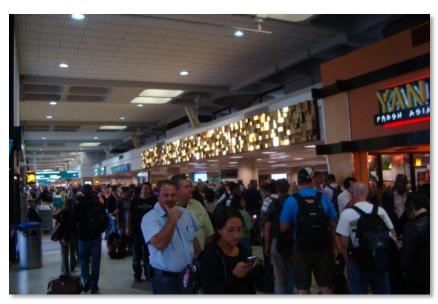
Lack of space for security screening operations prevents the introduction of appropriate security technologies with greater space requirements and the expansion of the current checkpoints, limiting throughput

Passengers queuing for T1 Security at 7:20am

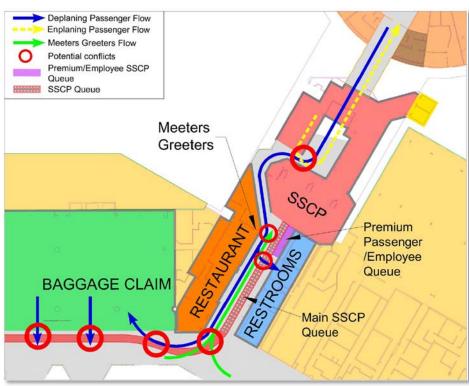
Terminal 1 East Security Screening Checkpoint Diagram

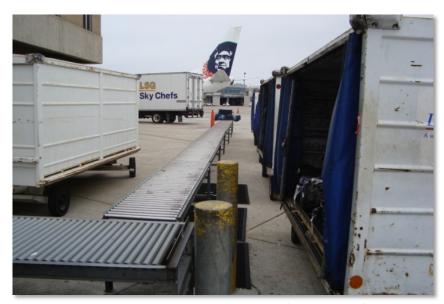
Lack of space for baggage screening and baggage handling systems may compromise baggage processing standards, in terms of quality (potential wet bags) and efficiency (timely delivery to aircraft)

Baggage make-up on the ramp

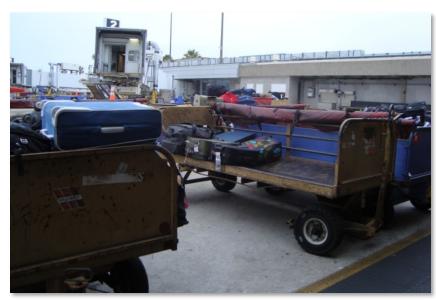
Baggage cart storage not under cover

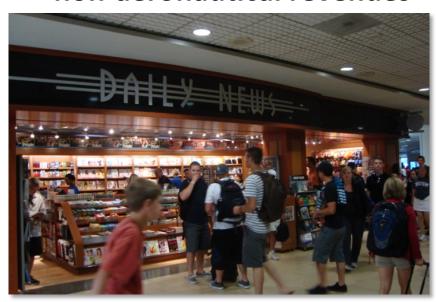
- Lack of space for concessions causes the retail program to underperform financially
- Represents a significant challenge for SDCRAA to increase non-aeronautical revenues

Limited concessions offerings

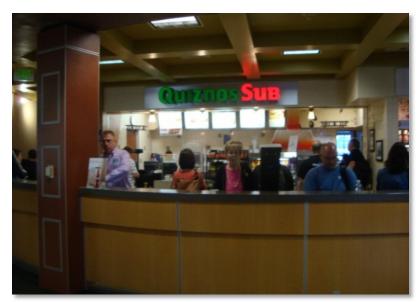
Limited food offerings

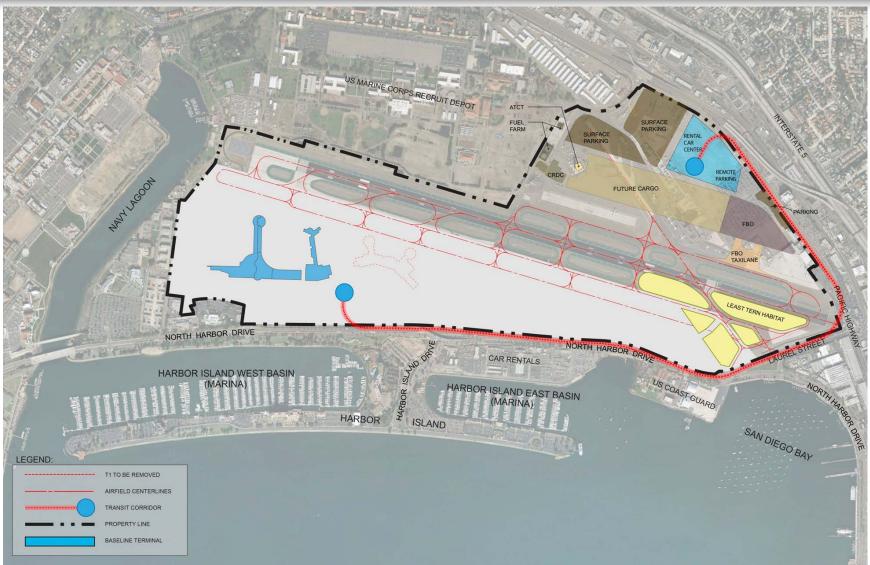
Constraints: Airfield

- Location of the two rotundas is providing an obstruction to needed improvements for airfield operations
- Configuration causes aircraft pushback constraints from some gates on to the existing active taxiway
