# 2025 Asbestos Reinspection

**September 2025**

San Diego County Regional Airport Authority

TETRA TECH, INC.

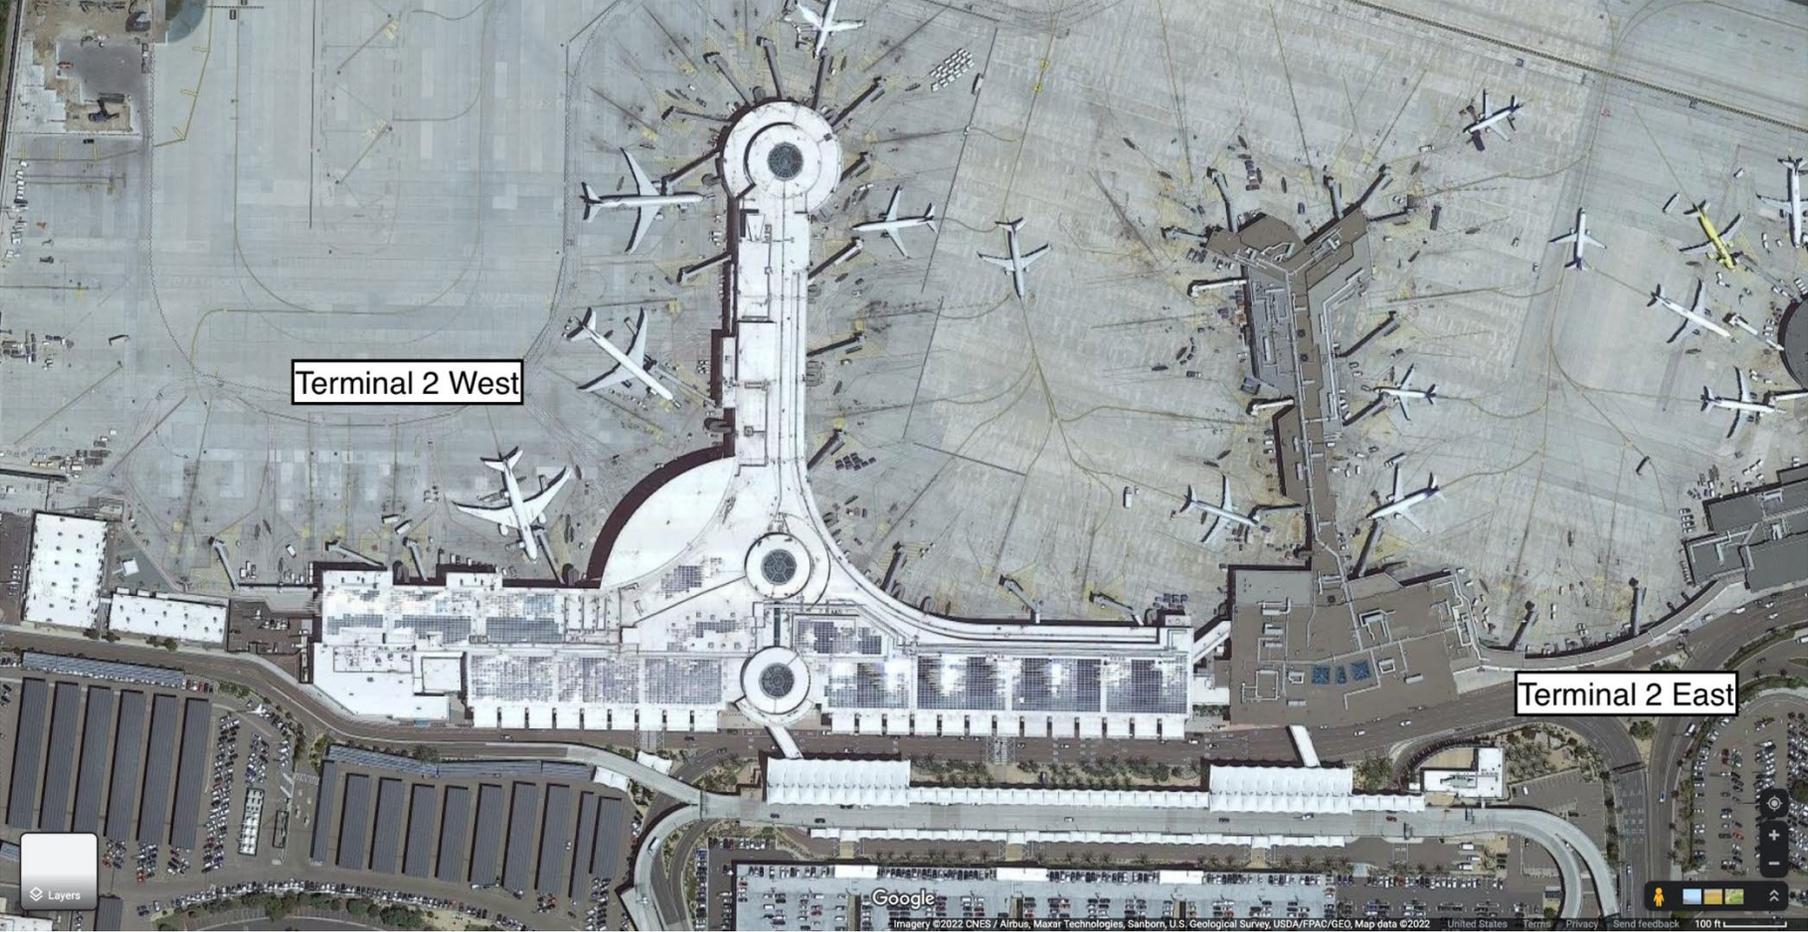
**3707 North Harbor Drive: Terminal 2 East**  
**Locations and Quantities of Asbestos Containing Materials**

## Locations and Quantities of Asbestos Containing Materials

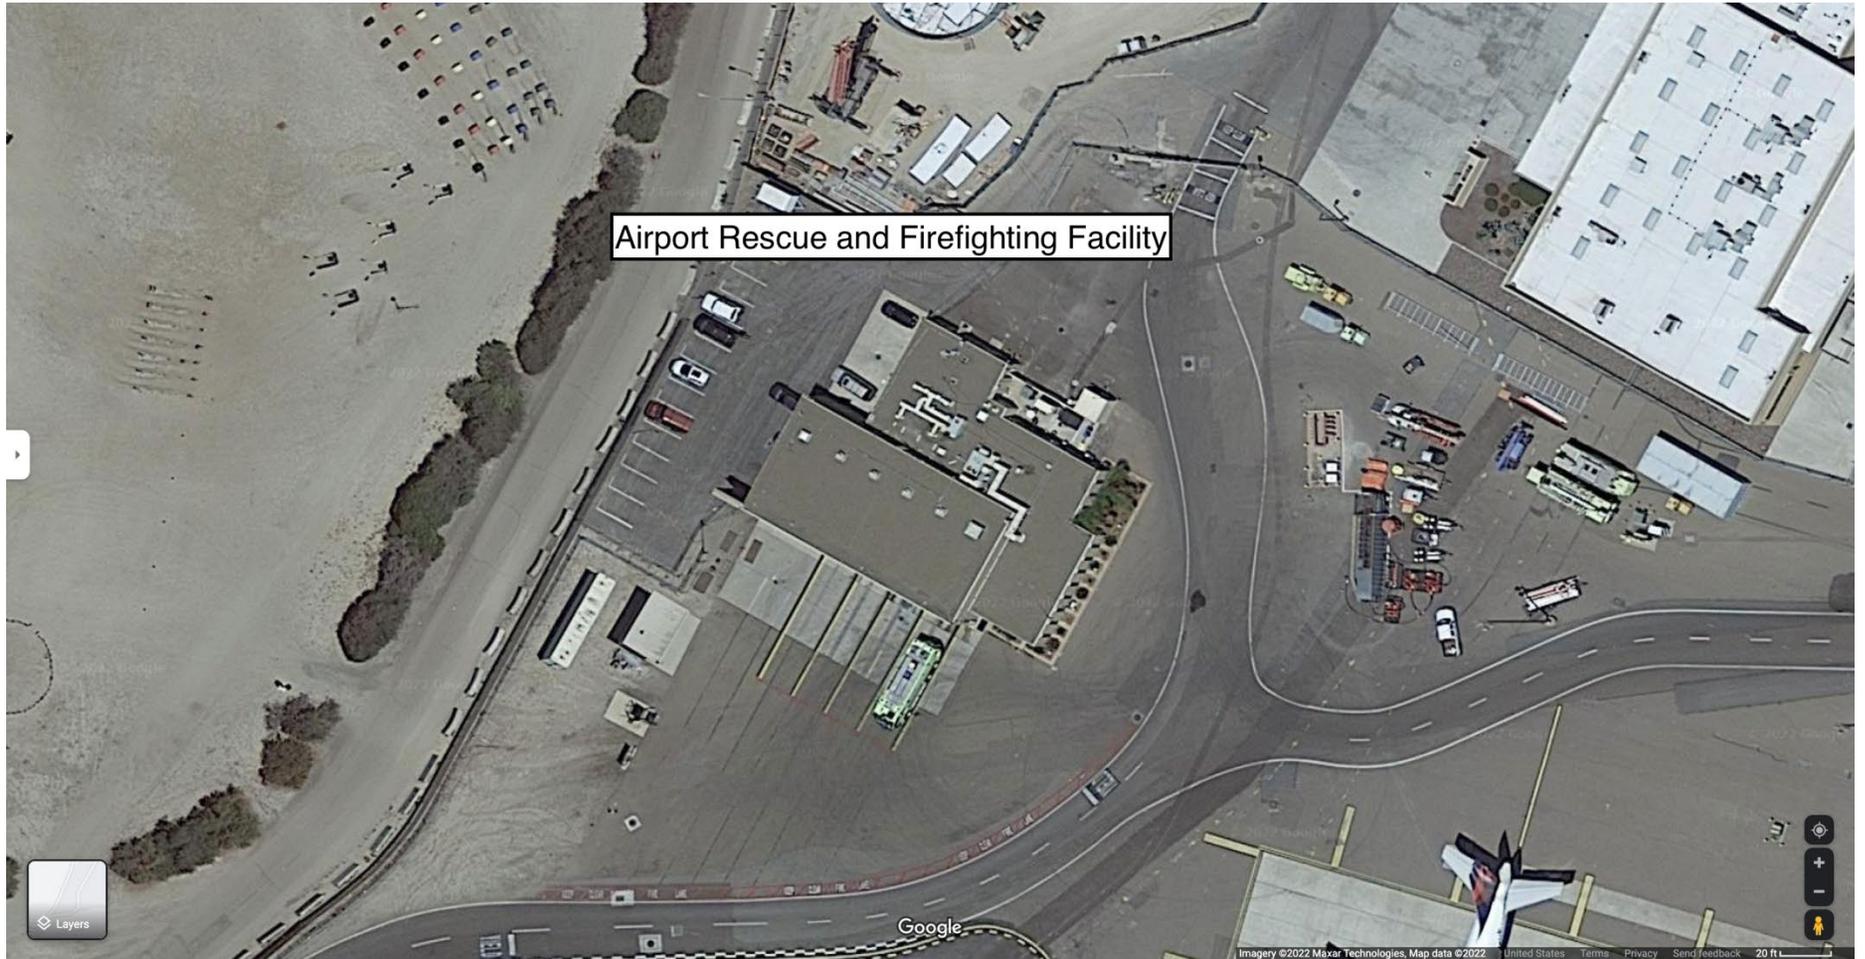
## Locations and Quantities of Asbestos Containing Materials

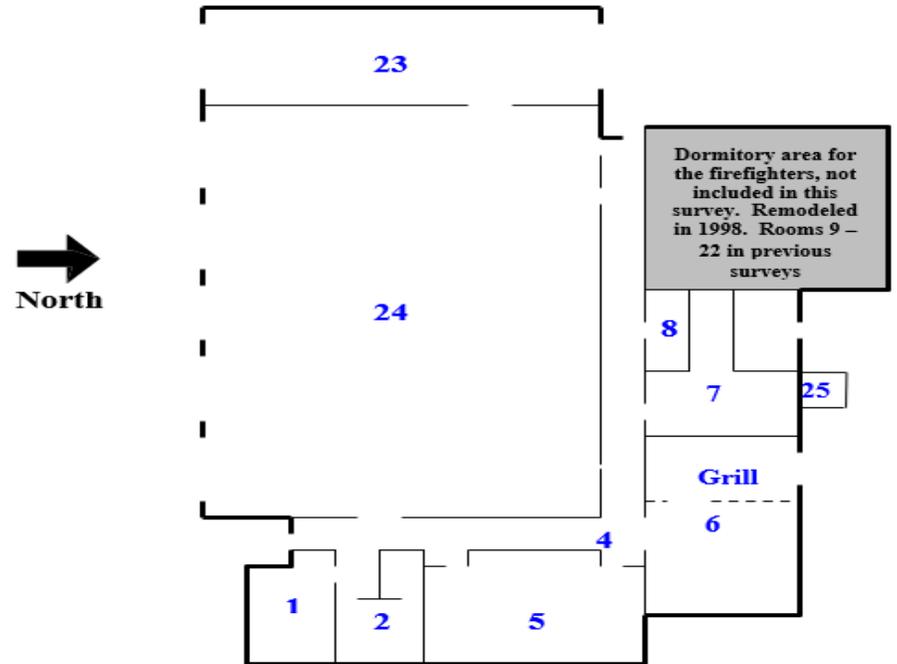
3698 Pacific Highway  
1<sup>st</sup> Floor  
Not to Scale

Room #	Room Description
1	Control Room
2	Captains Bedroom/Bathroom
4	Hallway
5	Training Room
6	Kitchen
7	Men's Bathroom and Shower
8	Women's Bathroom
9 – 22	Dormitory Area (Remodeled)
23	Gym
24	Main Garage Area
25	Hot Water Heater Room
