FedEx

Individual Tenant Summary From Appendix E

<p>SAN DIEGO INTERNATIONAL AIRPORT</p> <p>FedEx Operating Areas</p>	<p>FIGURE</p> <p>E-15</p>
--	---	---	----------------------------------

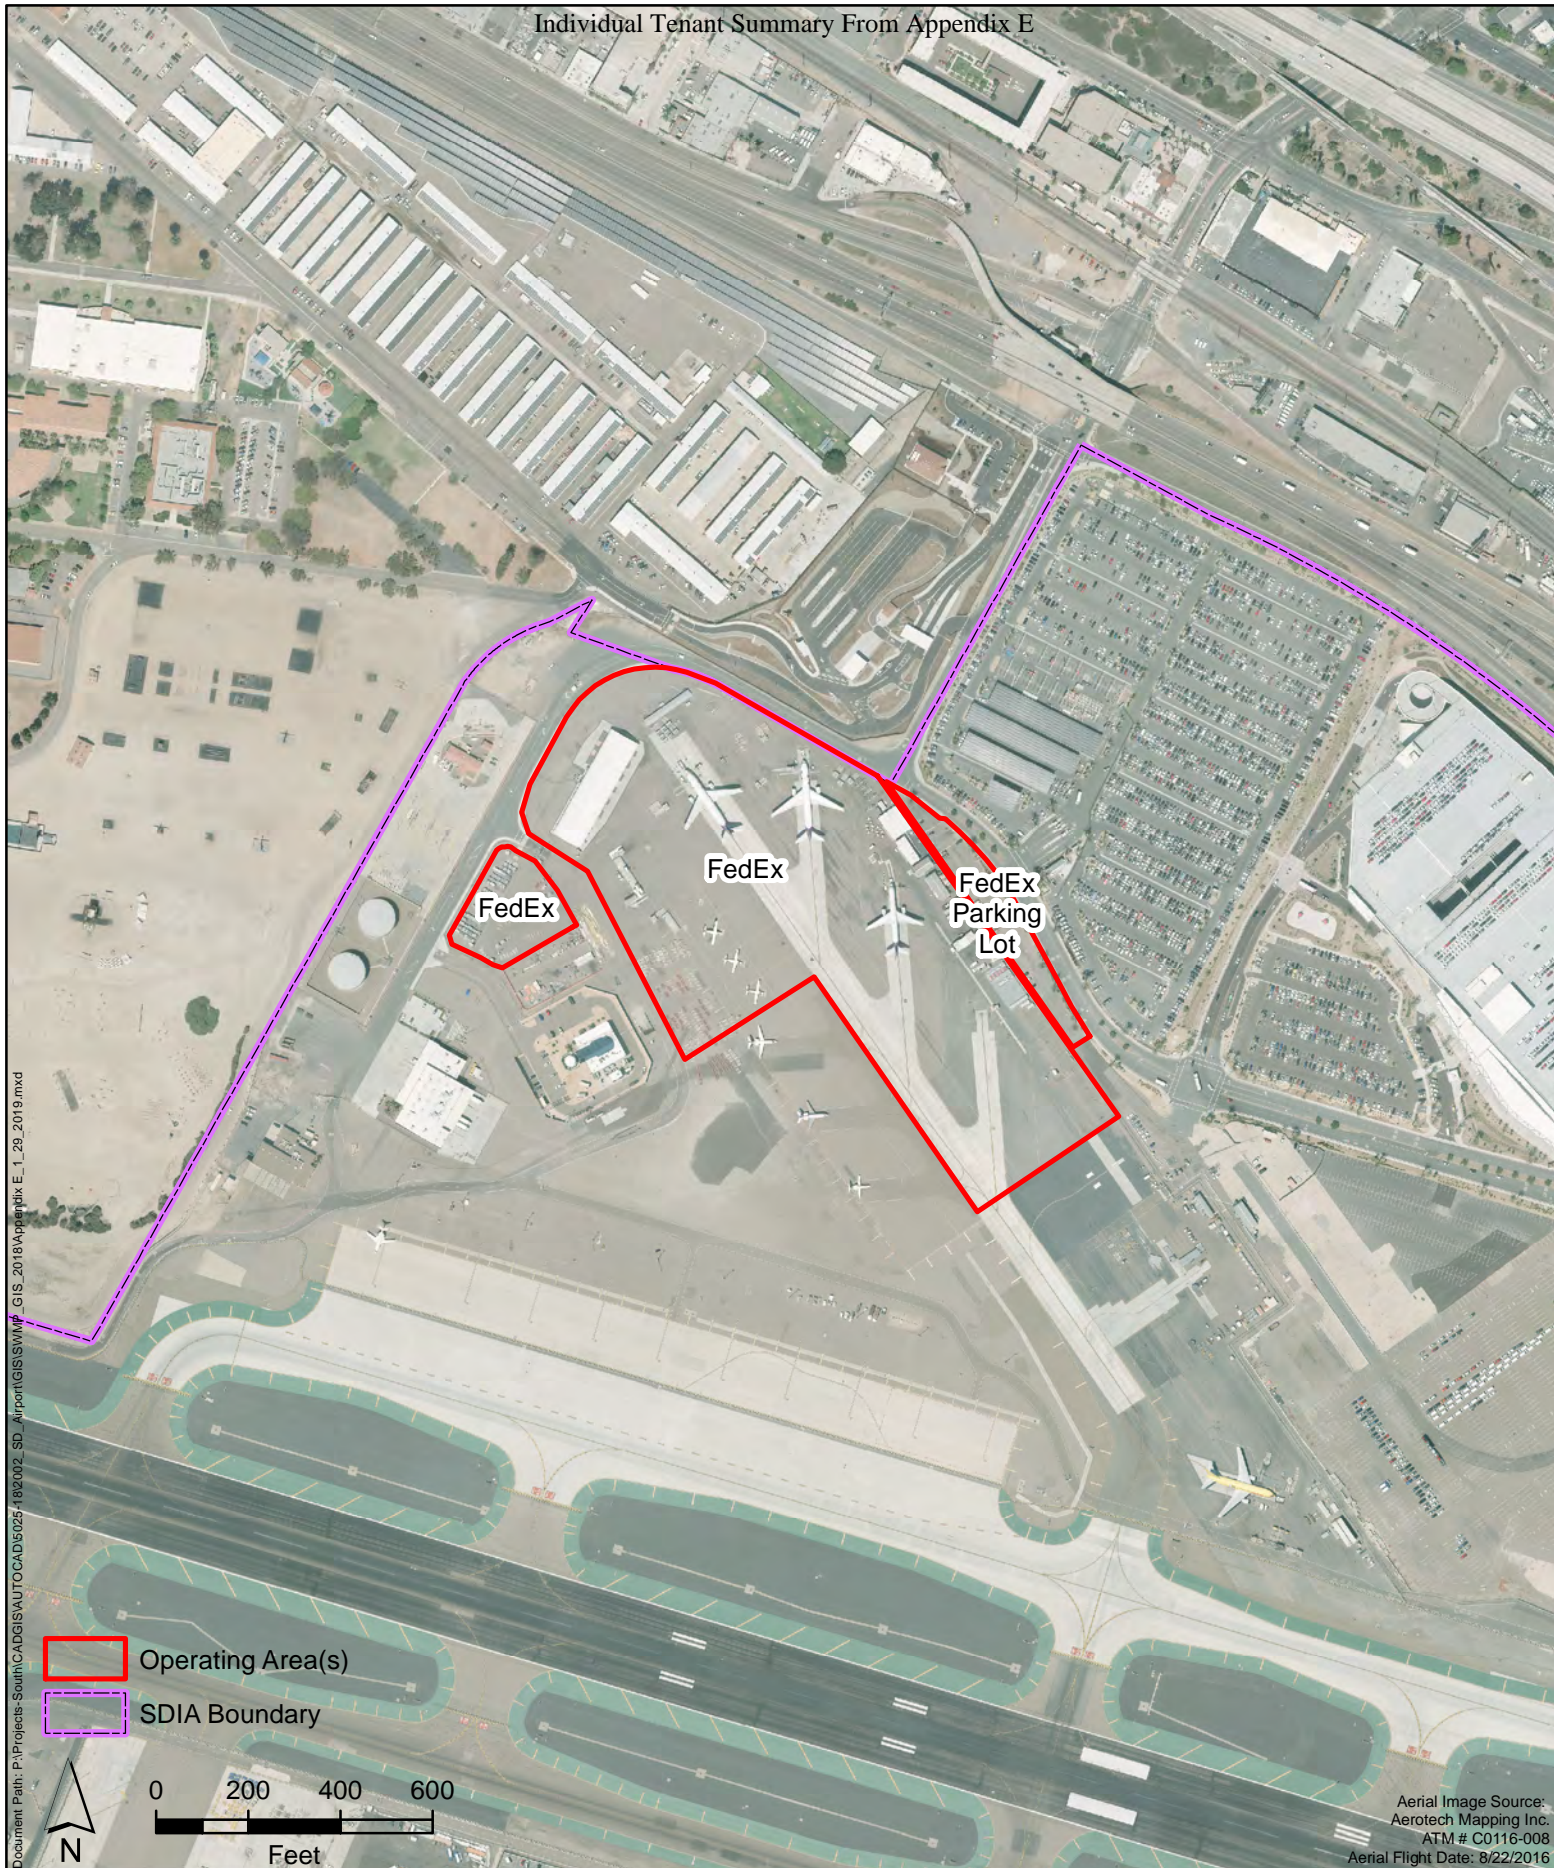
1. Aircraft loading/unloading occurs at four gates on the North Ramp area.
2. Menzies fuels aircraft, vehicles and equipment.
3. Two dumpsters utilized by FedEx's office are managed by EDCO and located outside of the parking lot.

5. A spill kit is located at the new sort facility. It contains absorbent litter, mats, and sox.
6. Minor vehicle maintenance is conducted outdoors in designated vehicle maintenance area. Maintenance area is covered and has a spill protection area.

7. Hazardous waste and waste oil are stored in covered storage containers, on pallets, and inside sheds southeast of FedEx's offices. Safety Kleen is contracted to pick up hazardous wastes.

10. Vehicles are parked in front of and northwest of FedEx's offices.
11. Cargo loading and unloading equipment is staged in designated areas throughout the ramp. The old sort facility is used for documents. Other operations are performed at the new sort facility under the new covered area.
