HISTORIC RESOURCES STUDY FOR THE PROPOSED AIRPORT DEVELOPMENT PLAN PROJECT AT THE SAN DIEGO INTERNATIONAL AIRPORT

CITY OF SAN DIEGO, CALIFORNIA

Type of Study: Historic Resources Survey and Historic Structure Evaluation;

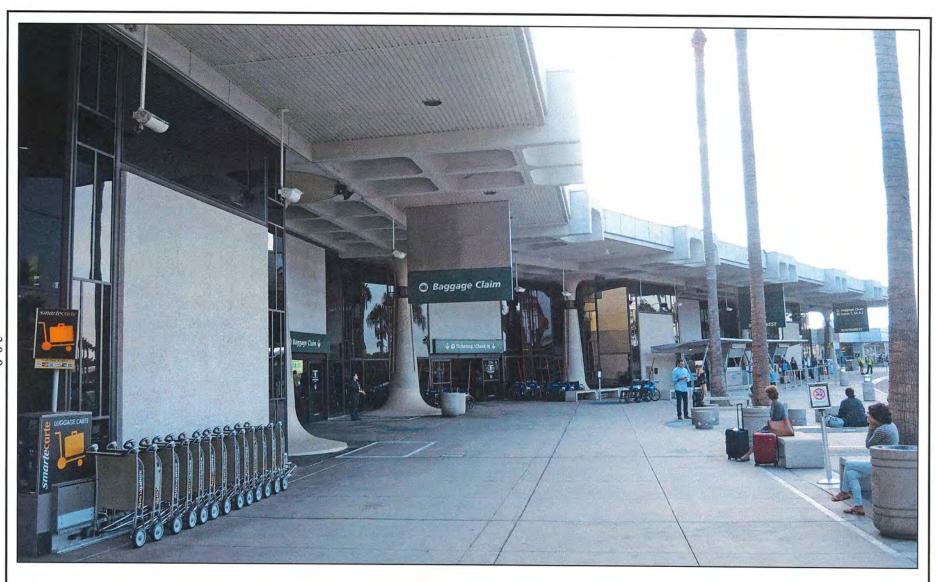
Plate 3.3.1–6
View of the Primary (South) Façade of Section A, Facing East

evenly spaced and create a repetitive pattern. The primary (south) façade of Section A currently exhibits is a mix of fixed-pane glass panels, concrete rectangular slabs, and automatic sliding glass doors (see Plate 3.3.1–6).

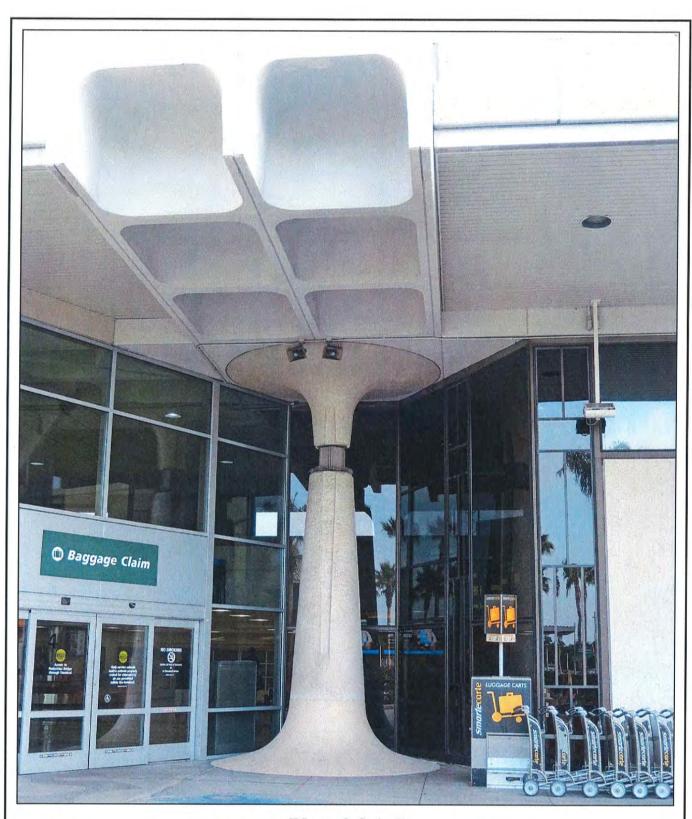
Plate 3.3.1–7
One of the 18 Support Columns on the Primary (South) Façade of Section A, Facing Northeast

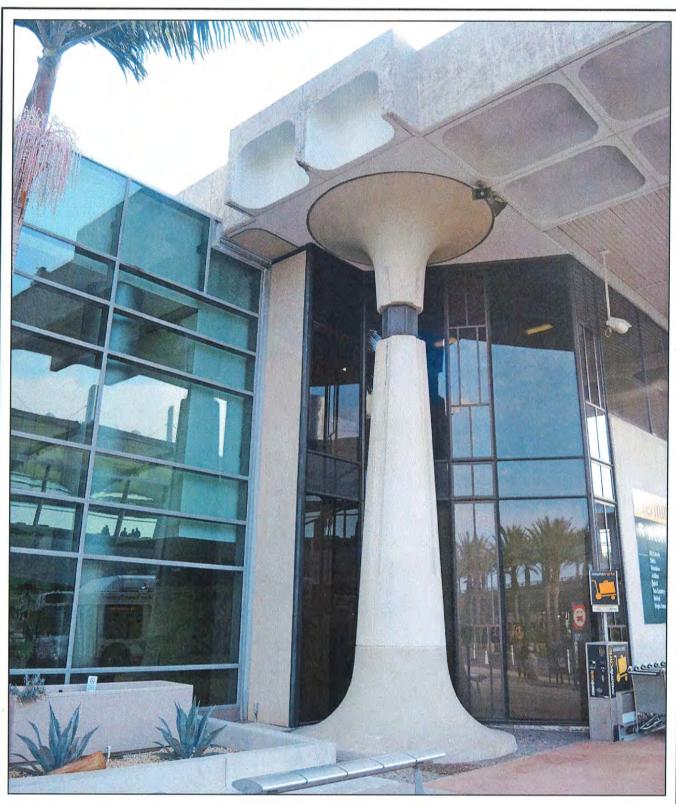
Plate 3.3.2-4

cantilevered, concrete overhang supported by 10 evenly spaced, poured-concrete columns. The columns taper toward the top quarter where they reach their narrowest point and reveal structural steel (Plate 3.3.2–4). The original overhang ceiling (Plate 3.3.2–5) exhibited the same deeply coffered roof system of curved, concave, curved square indentations that it currently exhibits (Plate 3.3.2–6). The coffered indentations on the cantilevered roof overhang are evenly spaced, create a repetitive pattern, and extend from the main structure past the roof overhang (Plate 3.3.2–7). When constructed, the wide overhang was entirely comprised of concrete (see Plate 3.3.2–5); however, it currently features a mixture of vinyl and concrete (see Plate 3.3.2–6). The primary (south) façade of Section A is currently a mix of fixed-pane glass panels, concrete rectangular slabs, and automatic sliding glass doors (Plate 3.3.2–8).

One of 10 Concrete Support Columns on the Primary (South) Façade of Section A, Facing Northeast

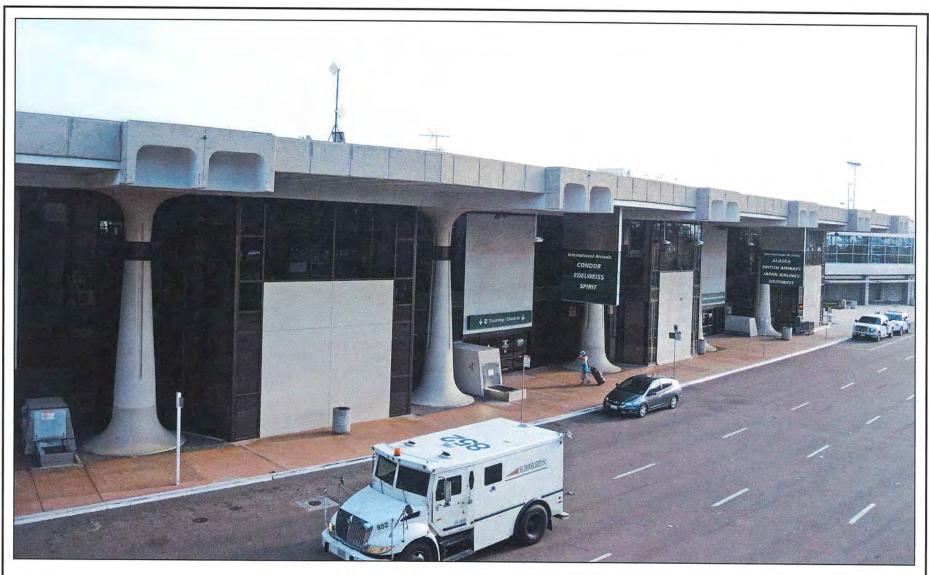
Plate 3.3.2–8
View of the Primary (South) Façade of Section A, Facing Northeast

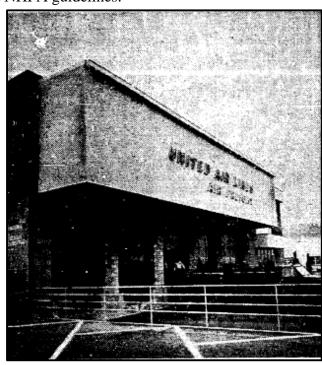
Plate 3.3.4–1: View of the west façade of the UAF building in 1968. (Photograph courtesy of San Diego Union 1968c)

date of construction. Plates 3.3.4–1 and 3.3.4–2 indicate that the UAF building once had a centered sign on the northwest façade; however, the current sign is off-center. Plate 3.3.4–2 also shows five matching loading dock doors, which have since been replaced with three corrugated metal roll-top doors and two paneled roll-top doors at an unknown date (Plate 3.3.4–3).

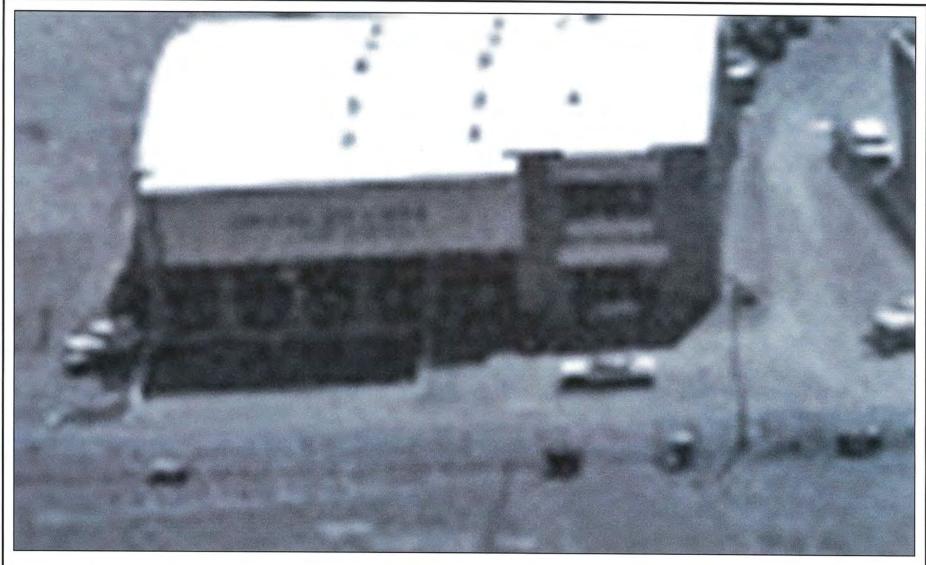
Plate 3.3.4–2 Circa 1968 to 1972 Aerial View of the West Façade of the UAF Building

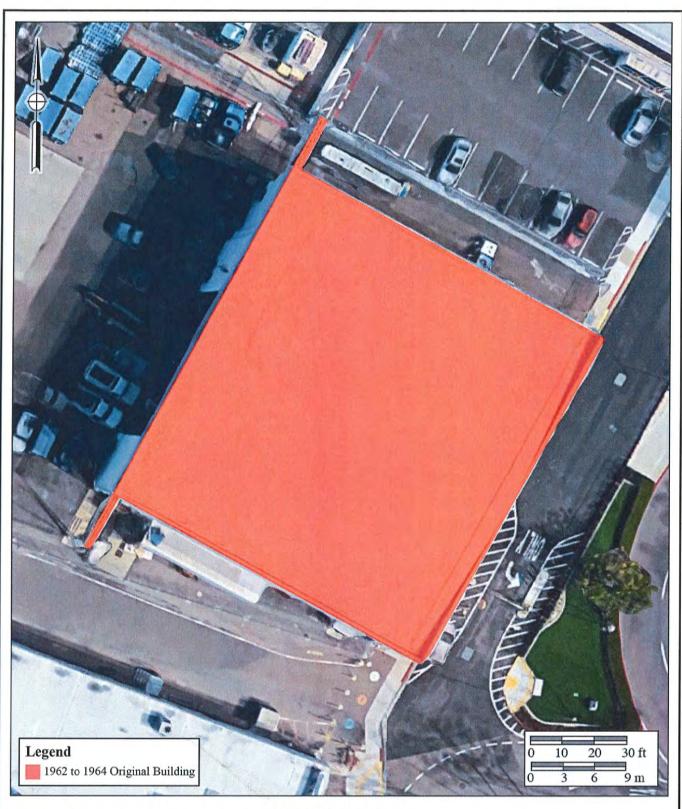
Figure 3.3.6–1 Site Plan for the AOH Building Site P-37-036761

The AOH building has a rectangular footprint, measures approximately 104 by 107 feet, with no decorative elements. The building has a flat roof and all four façades are covered in corrugated aluminum siding. The east façade of the building has five metal-framed pivot windows, three pedestrian entrances, and two sliding doors (Plate 3.3.6–1), the north façade has metal-framed pivot windows (Plate 3.3.6–2), the south façade has two pedestrian entrances (Plate 3.3.6–3), and the west façade has five sliding door panels (Plate 3.3.6–4). The doors to the hangar utilize three overhead tracks that extend to the north (Plate 3.3.6–5) and south (Plate 3.3.6–6) of the west façade. The tracks enable the hangar doors to be opened beyond the building walls in order to not interfere with the passage of large aircraft in and out of the building.

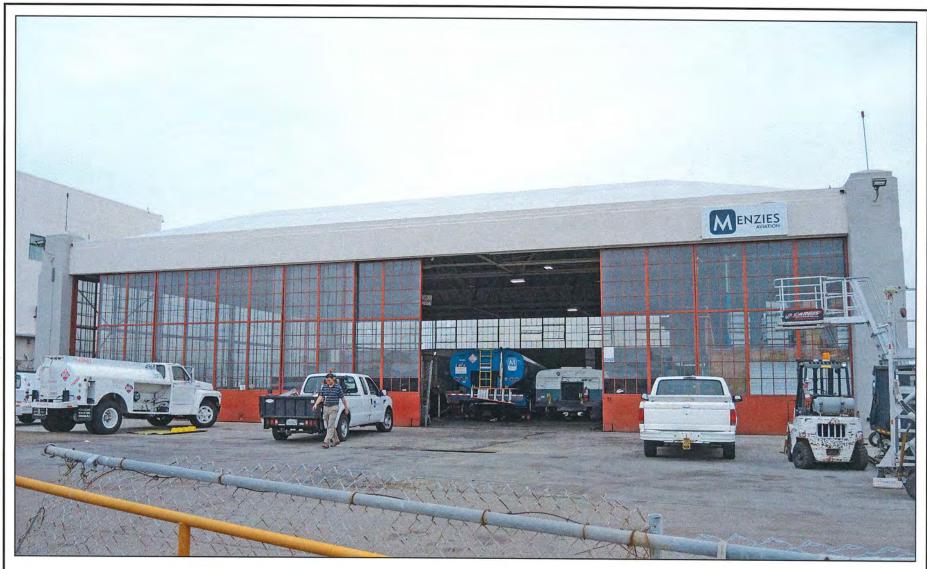
Plate 3.3.7–4
View of the North Façade of the UAHT Building, Facing South

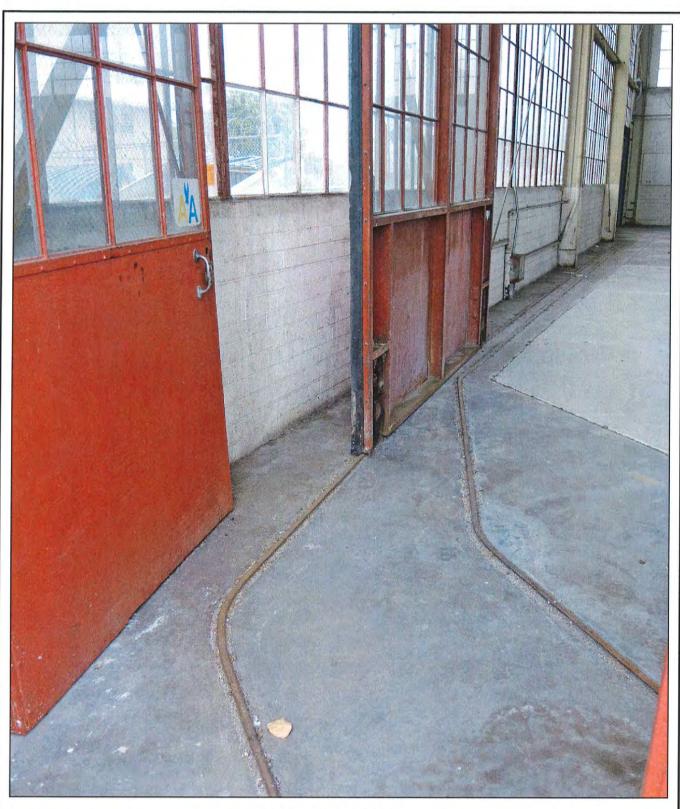
Plate 3.3.7–6
View of the Tracks for the Sliding Hangar Doors
on the UAHT Building, Facing Southeast

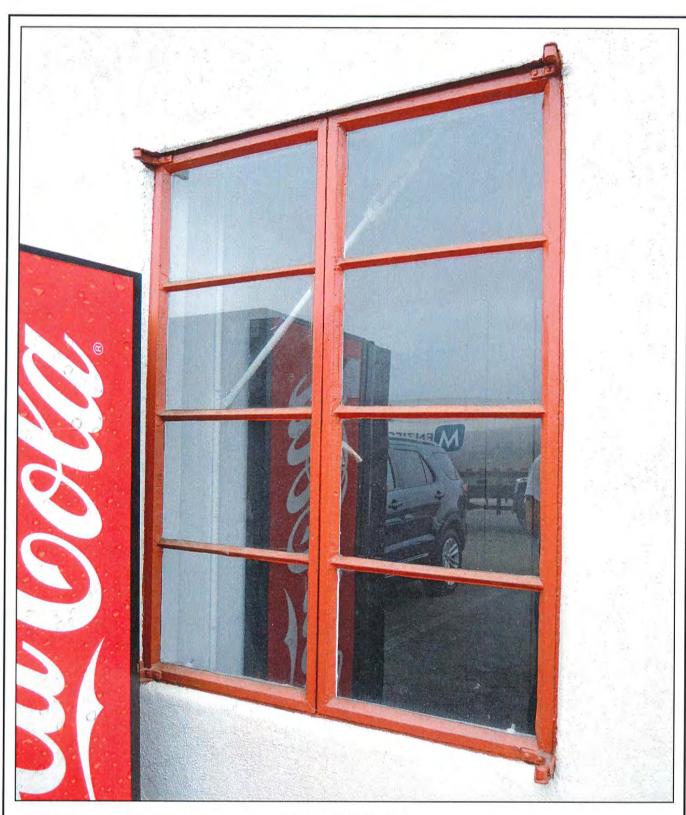
Plate 3.3.7–16
View of a Metal-Framed, Casement-Style Window on the West Façade of the UAHT Building, Facing East

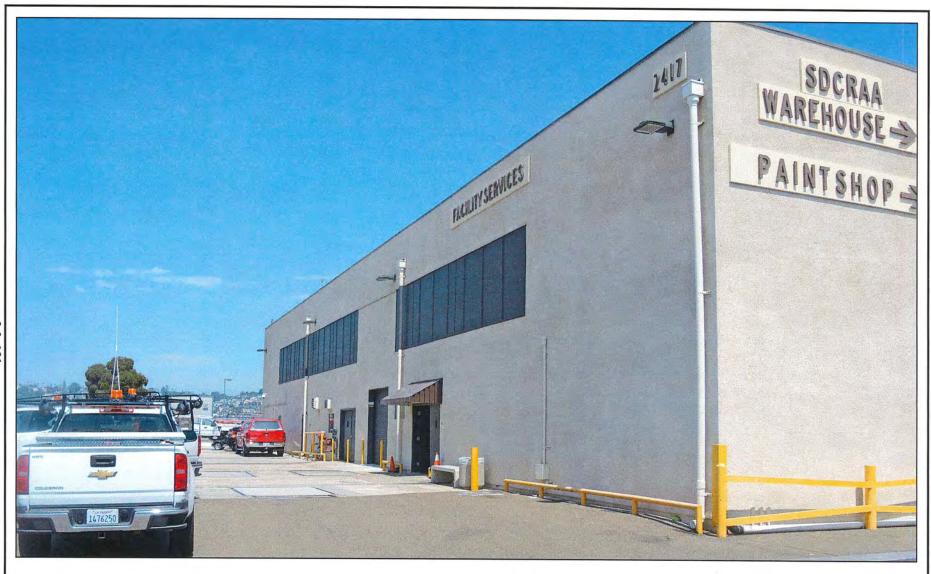
The JEO building was originally designed as a simple, unadorned, utilitarian, industrial-style building. The building exhibits no stylistic elements and is not representative of any particular architectural style. The JEO building currently exhibits an approximately 150-by-200-foot rectangular footprint, has a three-barreled roof, and is entirely clad in stucco. The west, south, and east façades exhibit a parapet wall at the roofline; the north façade has a flat roofline with no parapet.

Plate 3.3.8–2
View of the Primary (West) Façade of the JEO Building, Facing North

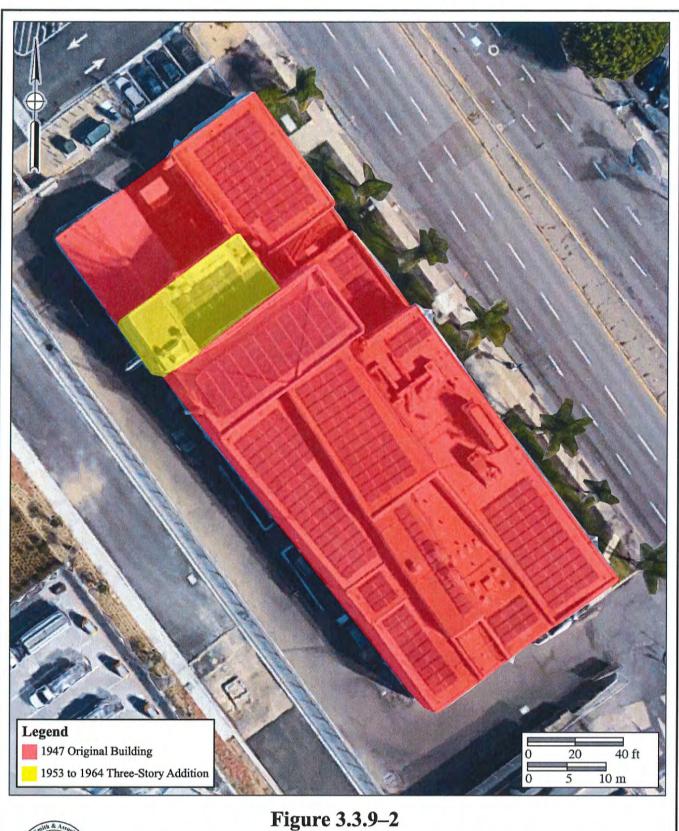
Figure 3.3.9–2 Site Plan for the CWT Building Site P-37-015548

The CWT building is still currently being used as a testing facility, which involves producing complete scale models of aircraft or various aircraft parts that are placed inside the tunnel (Plate 3.3.9–5). Air is then passed over the scale models so aspects of lift and drag can be measured. Called a "low speed wind tunnel," the CWT building was, and still is, capable of generating a maximum wind speed of 270 miles per hour. During testing, this "low speed" air current is propelled (Plate 3.3.9–6) through a wall of boards called turning vanes (Plate 3.3.9–7). The air is pushed into a triangular room before being blasted through a honeycomb wall into an eight-foot-tall, 12-foot-wide, 15-foot-long room. The small room has large windows on either side that allow engineers to view the testing from the adjacent control room (Plate 3.3.9–8). Currently, video camera feeds of the testing sessions are displayed in the control room. The CWT building has been used to test Boeing jetliners, fighter jets, and the Space Shuttle, as well as other various structures and items such as Qualcomm Stadium, camping tents, and cell towers. In 2006, the CWT building was purchased by the San Diego Air and Space Museum and is now known as the San Diego Air and Space Technology Center (Masunaga 2017).
