**EXCAVATED SOIL MANAGEMENT PLAN  
SAN DIEGO INTERNATIONAL AIRPORT  
SAN DIEGO, CALIFORNIA 92101  
KLEINFELDER PROJECT NO. 20202318.004A**

**MARCH 23, 2026**

**EXCAVATED SOIL MANAGEMENT PLAN  
SAN DIEGO INTERNATIONAL AIRPORT  
SAN DIEGO, CALIFORNIA 92101**

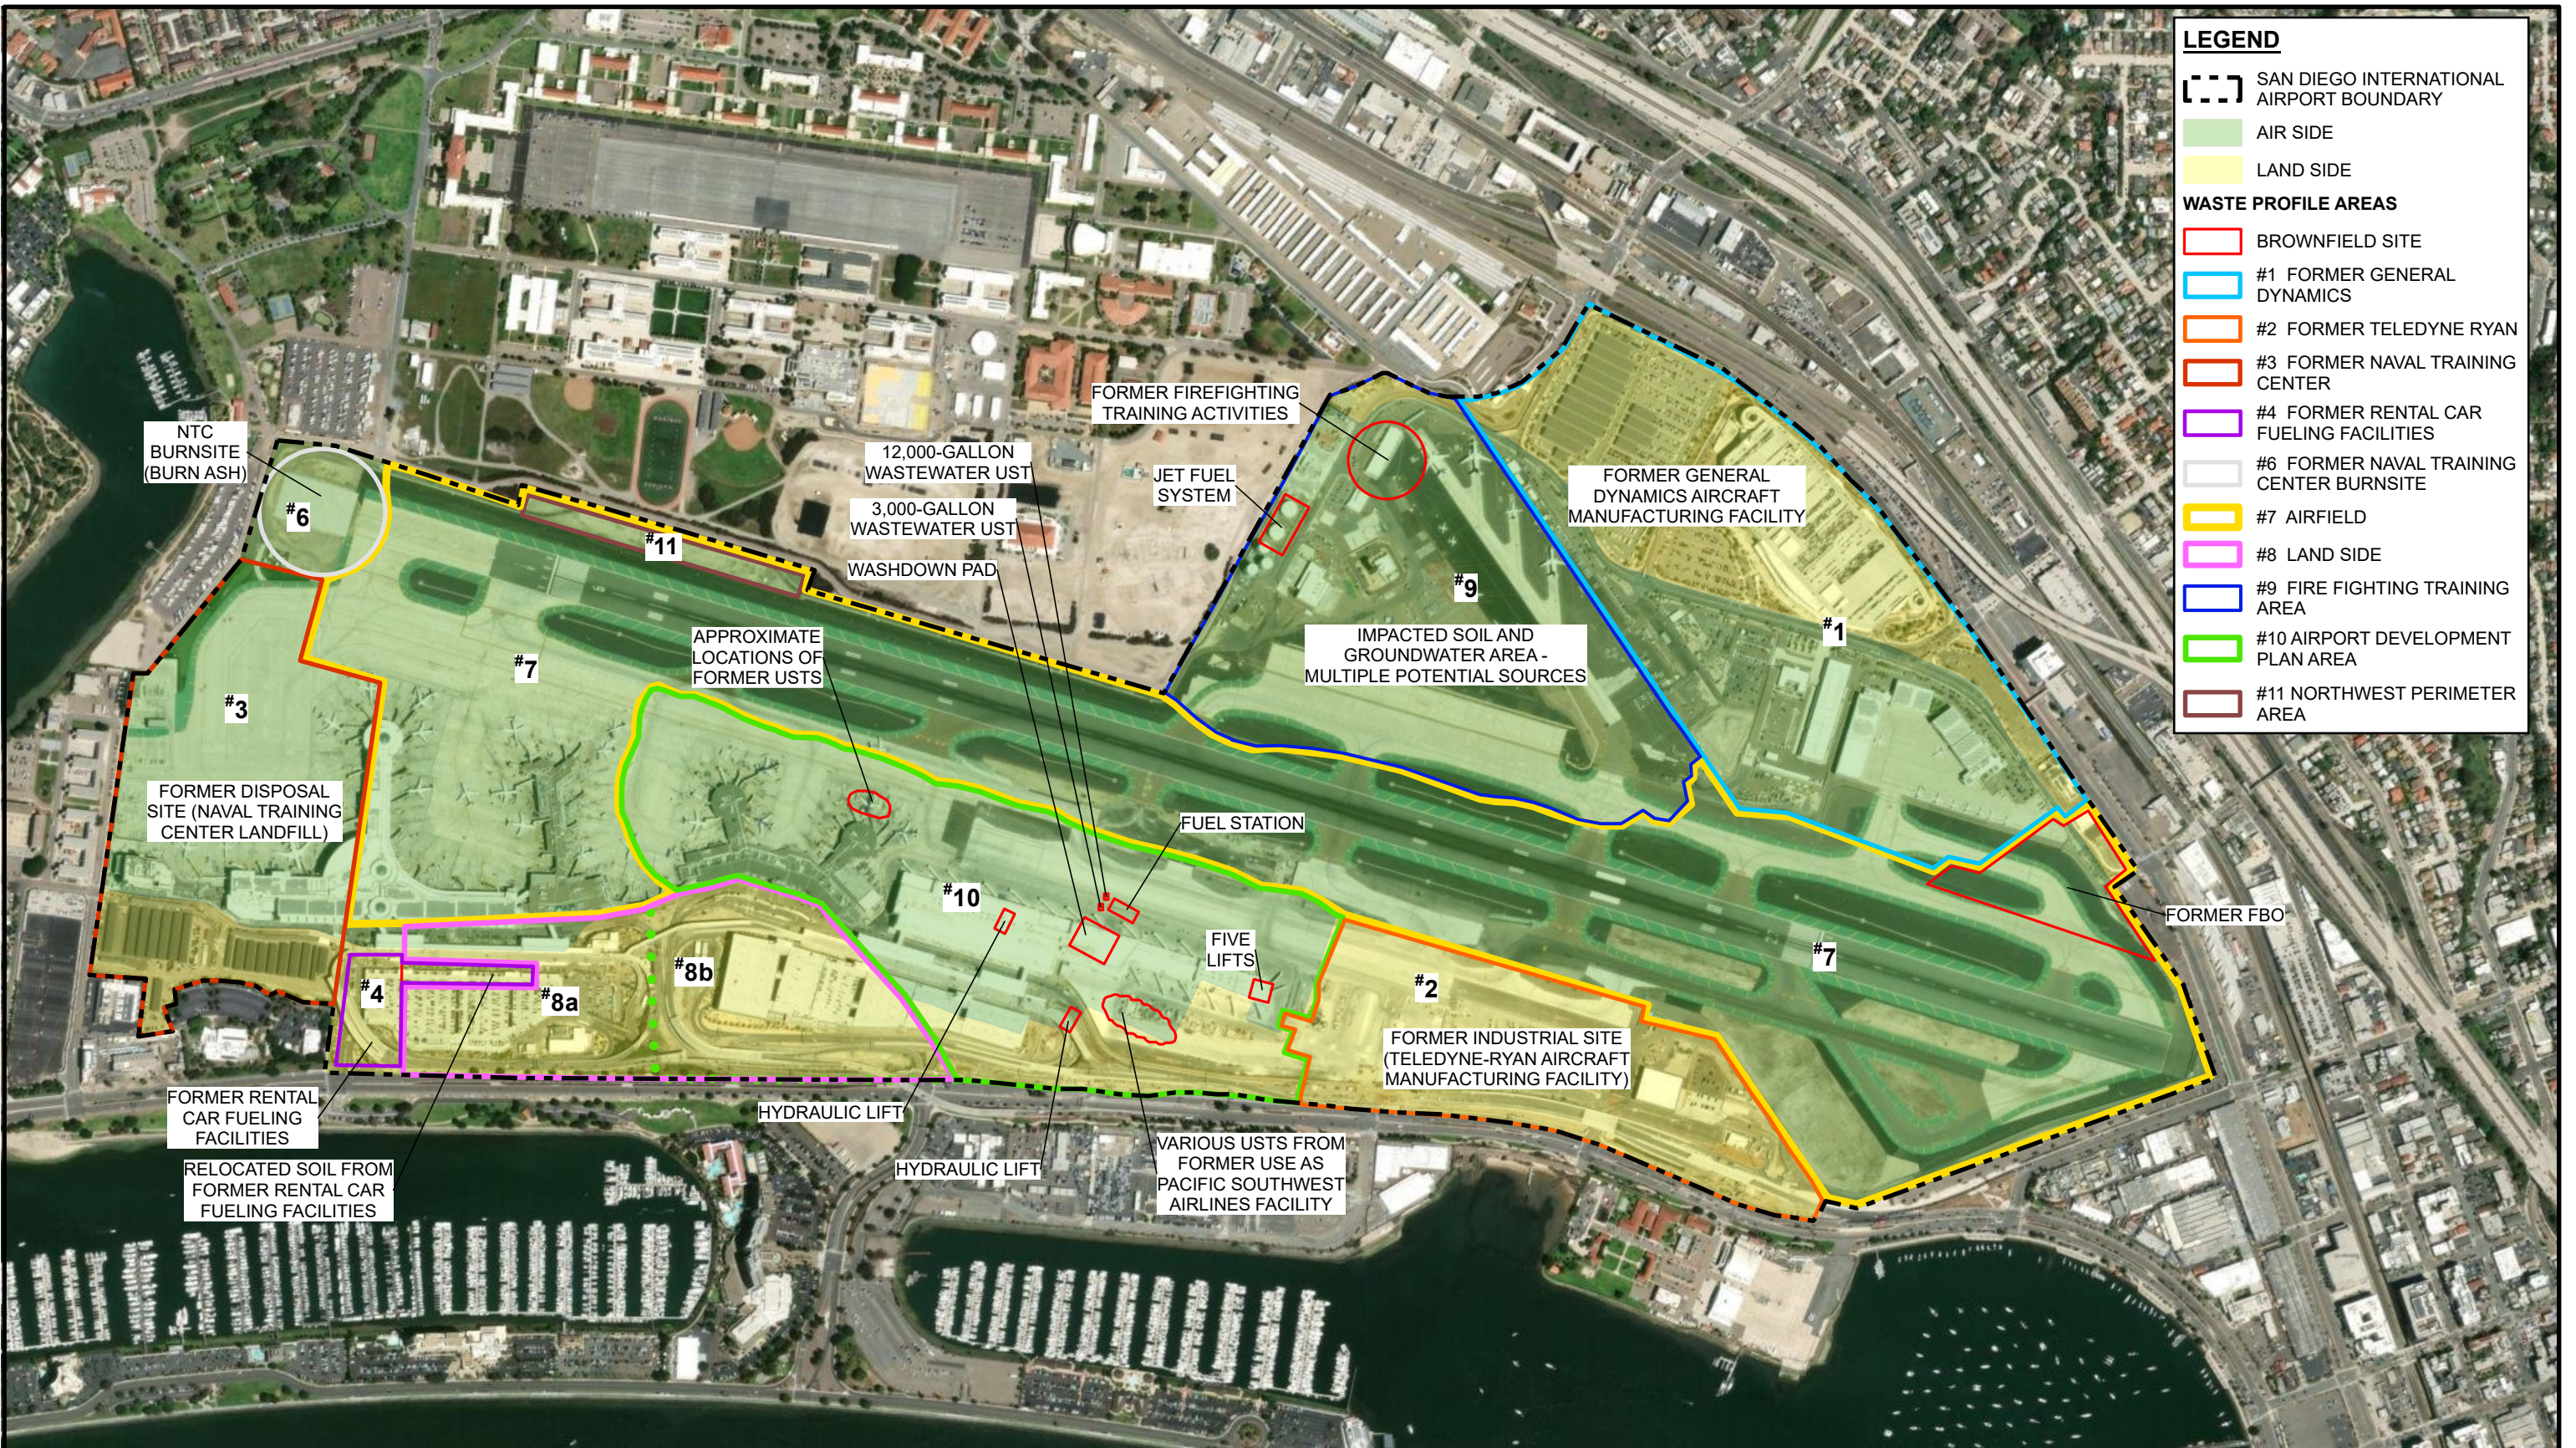
**SDIA WASTE PROFILE AREAS  
EXCAVATED SOIL  
MANAGEMENT PLAN**

Burn ash cannot be reused on-Site and must also be disposed of at the Copper Mountain Landfill. Figure 1 shows the geographic extent of each profile area. Table 1 below includes the waste profile information associated with each profile area.

- BROWNFIELD SITE
- #1 FORMER GENERAL DYNAMICS
- #2 FORMER TELEDYNE RYAN
- #3 FORMER NAVAL TRAINING CENTER
- #4 FORMER RENTAL CAR FUELING FACILITIES
- #6 FORMER NAVAL TRAINING CENTER BURNSITE
- #7 AIRFIELD
- #8 LAND SIDE
- #9 FIRE FIGHTING TRAINING AREA
- #10 AIRPORT DEVELOPMENT PLAN AREA
- #11 NORTHWEST PERIMETER AREA
